Incident Investigation Report

Site: Dunbar

Location: Active Cell

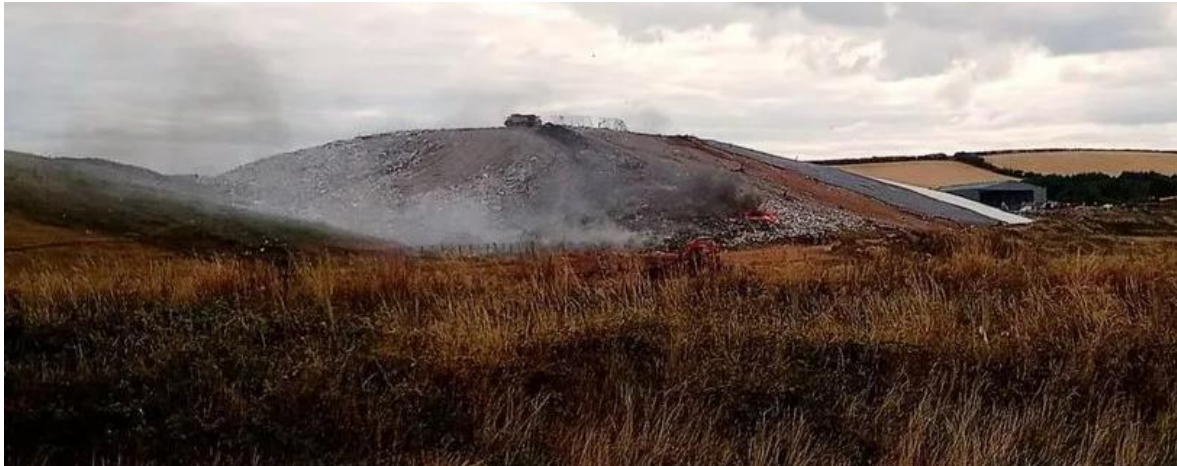
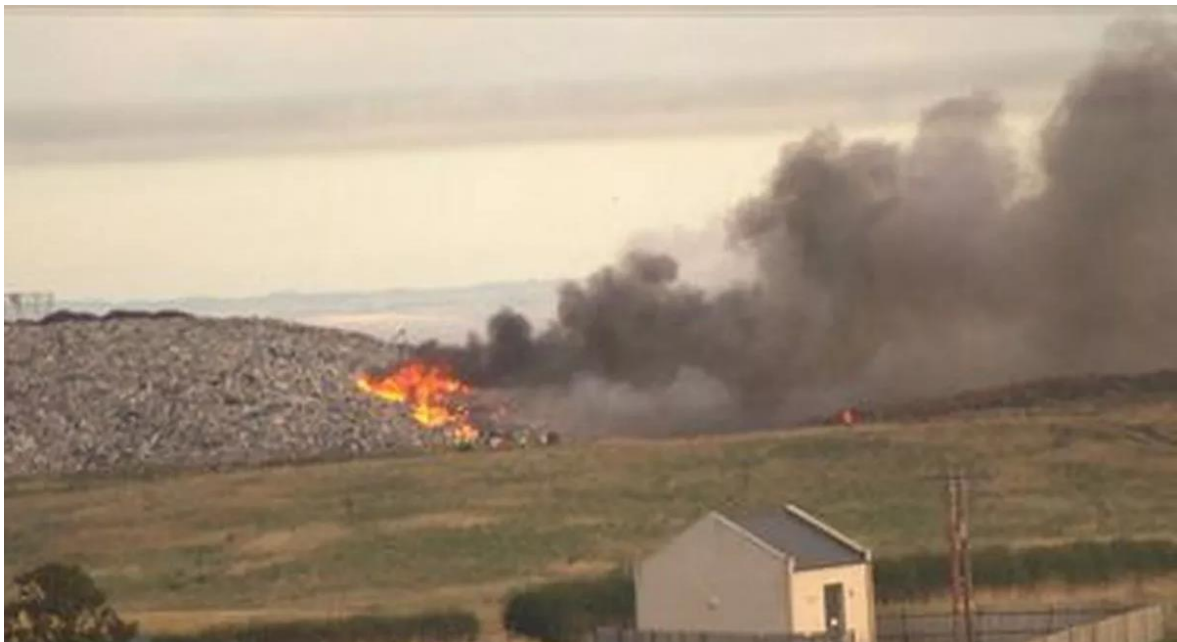
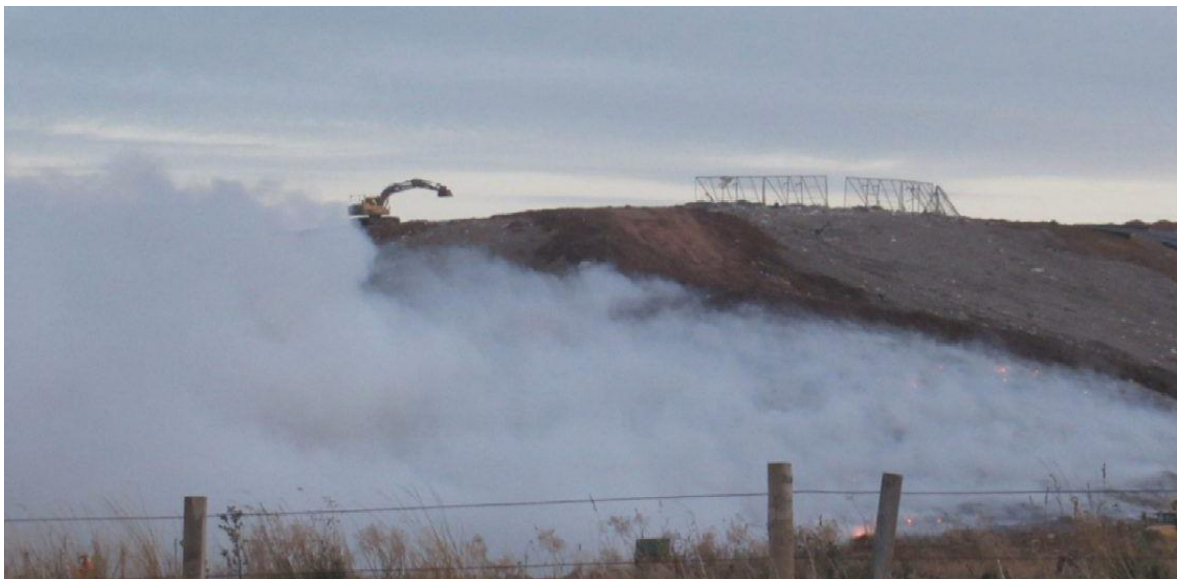
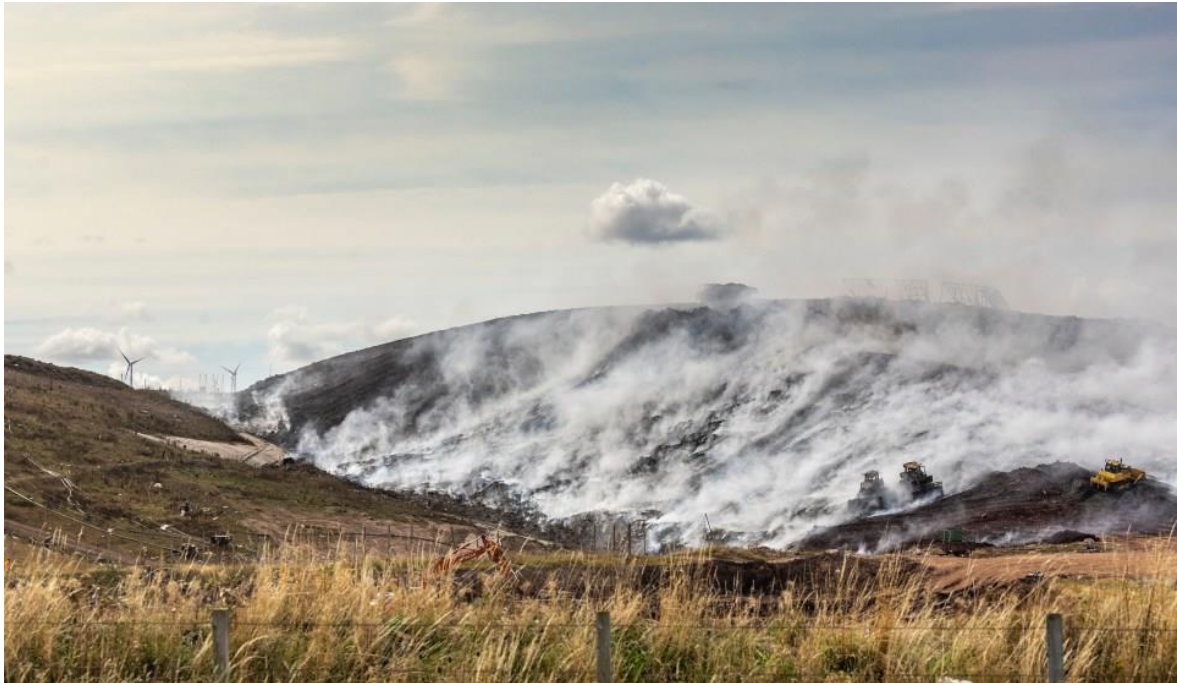
Obtain General Information							
Date and Time of Incident				28 th August 2023 – 13:50			
Fatal or Major	<input type="checkbox"/>	Serious	<input checked="" type="checkbox"/>	Minor	<input type="checkbox"/>	Damage Only	<input checked="" type="checkbox"/>
First Response to Incident				Firefighting, gas isolation, smother with inert material			
Injured Person(s)				0			
Witness(es)				[REDACTED] & Viridor ERF called Fire Brigade			
First on Scene in order of attendance				[REDACTED], Fire Brigade, [REDACTED], [REDACTED]			
Equipment/Infrastructure				2 x Dozer – lost 7 x Gas wells lost 1 x Leachate well lost Cell to be monitored before recommencing waste inputs.			
Environmental Conditions				Temp 18 C, Rainfall morning Wind speed above average 15mph Wind direction – West, SouthWest			
Record - take photographs				See Appendix A of Google images
